**Equivalent Fire Resistance Ratings
of Construction Elements
Exposed to Realistic Fires**

A research report presented as partial fulfilment of the requirements for the Degree of
Master of Engineering in Fire Engineering.

Department of Civil Engineering
University of Canterbury
Christchurch, New Zealand

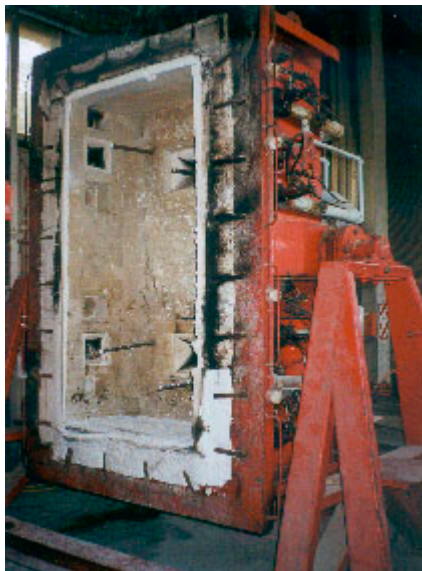
Figure 2.2 – Pilot scale test furnace at BRANZ.

Additionally, small scale furnace fire resistance testing can be undertaken using a pilot furnace, shown in Figure 2.2, with an opening size of 2.1m high by 1m wide. However, Buchanan (2001a) explains that although such small scale testing is cheaper than full-scale testing, full assessment of the potential problems caused by construction connections, shrinkage, deflections and gaps between panels of lining materials, is not possible with small-scale testing. Pilot scale testing is most commonly used to supplement data already gathered from a full-scale test.

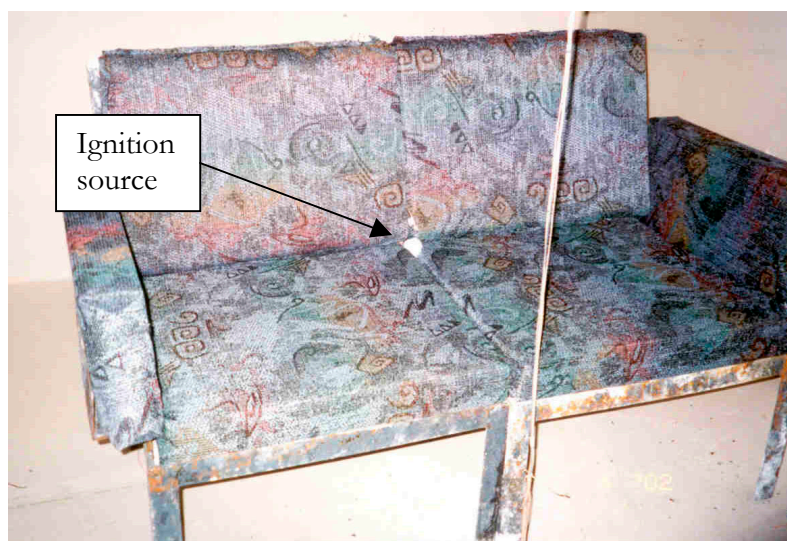
Figure 3.18 – Ignition source location

The ignition source for all fire tests was a cotton wool swab moistened lightly with methylated spirits. The swab was located at the join between the seat cushions and the seat back cushions in the centre of the two, or three seater chairs (Figure 3.18), and ignited using a match.

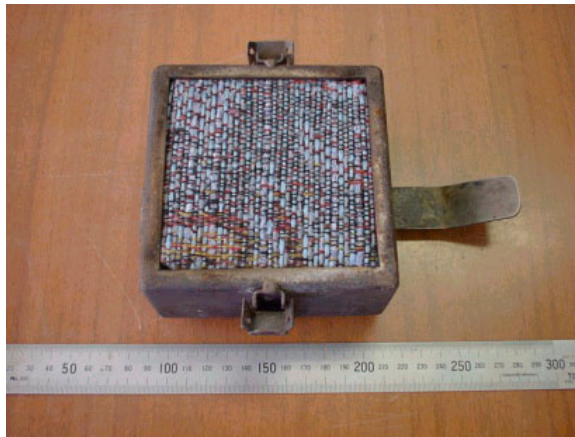
Figure 6.3 – Foam and fabric sample in holder (typical)

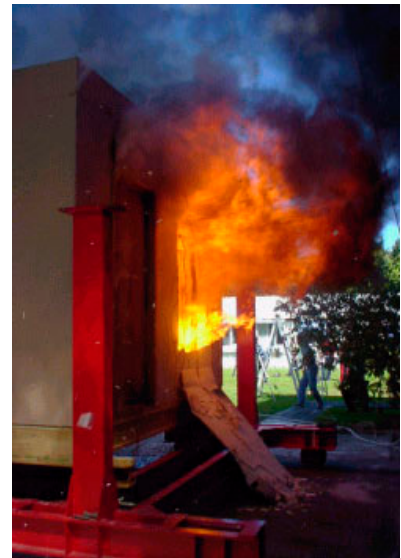
22 min (Assembly #3
integrity failure)

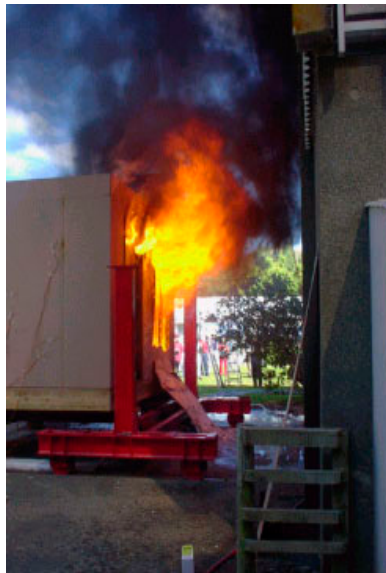
22 min 30 sec (Fire door
integrity failure)
